INSTALLATION RESTORATION PROGRAM
PHASE II - CONFIRMATION/QUANTIFICATION
STAGE 1

FINAL REPORT
FOR
AIR FORCE PLANT 4
FORT WORTH, TEXAS

VOLUME 1. REPORT TEXT

DECEMBER 1987

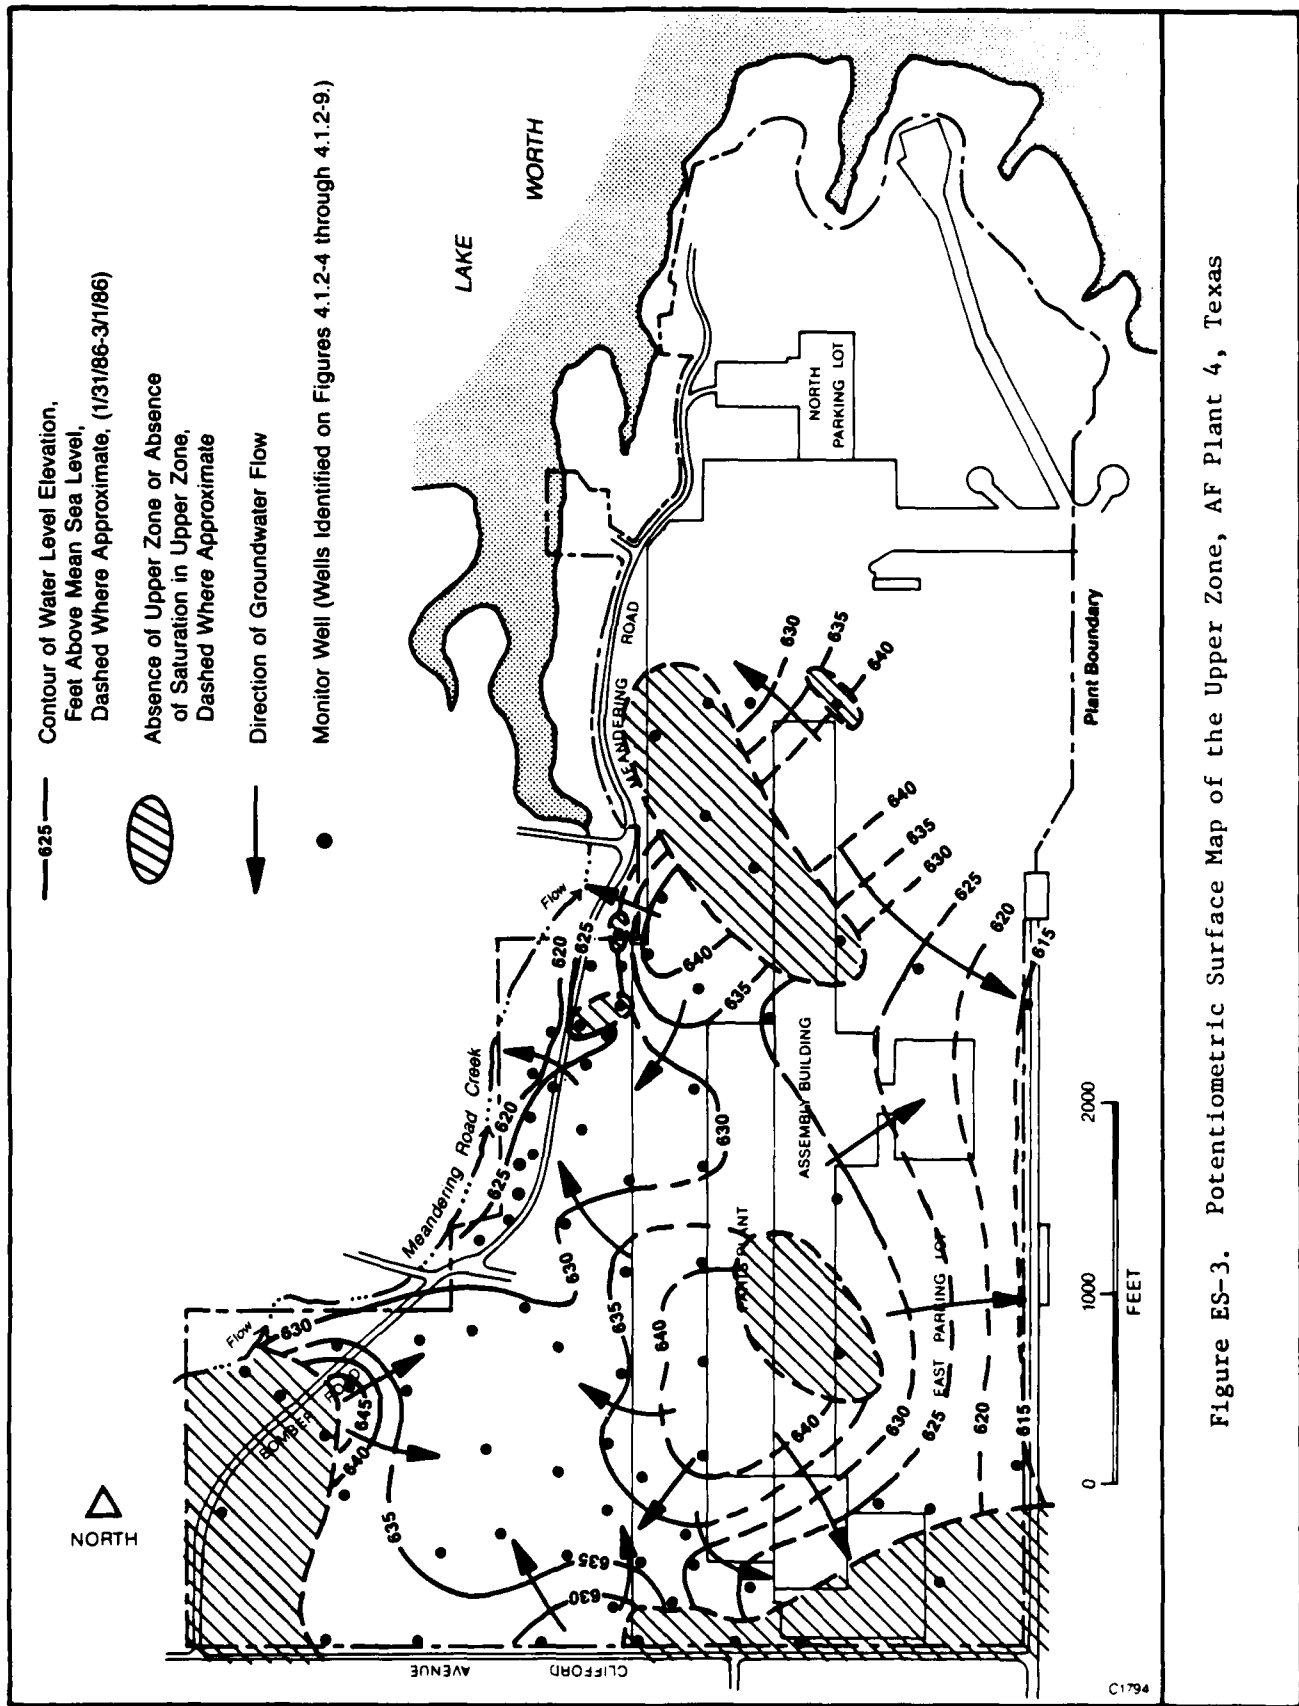
Figure ES-3. Potentiometric Surface Map of the Upper Zone, AF Plant 4, Texas

Hydrogeologic data gathered for this investigation consisted of water-level readings at existing and new upper zone and Paluxy monitor wells. Figure ES-3 depicts the potentiometric surface in the upper zone, based on Phase II Stage 1 monitoring. The occurrence and flow of groundwater is

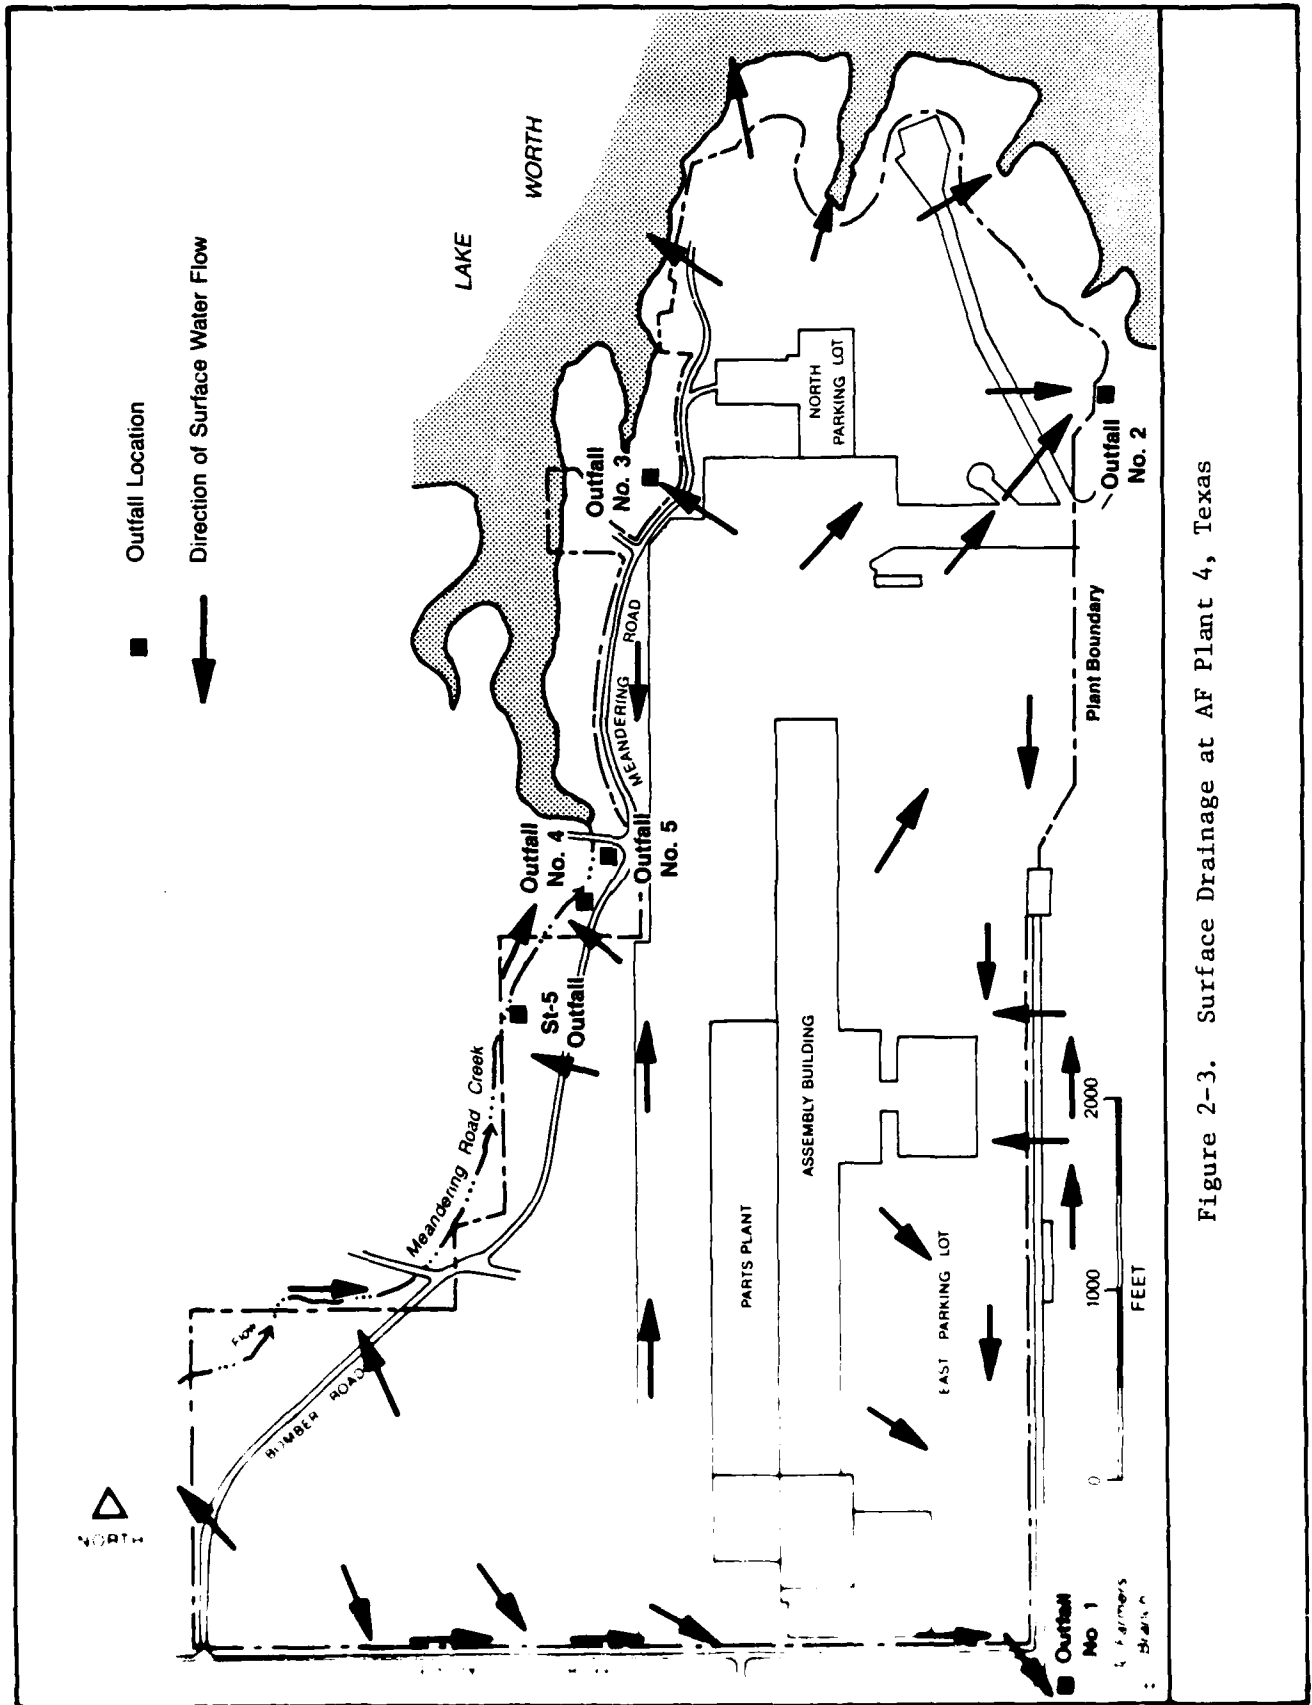
Figure 2-3. Surface Drainage at AF Plant 4, Texas

Surface drainage at AF Plant 4 is intercepted by storm drains and culverts and is discharged to Lake Worth, the Meandering Road Creek, or a tributary of Farmer's Branch. AF Plant 4 is partially drained by Farmer's Branch, which in turn discharges into the West Fork Trinity River east of Carswell Air Force Base. Figure 2-3 shows the direction of surface water flow at AF Plant 4.

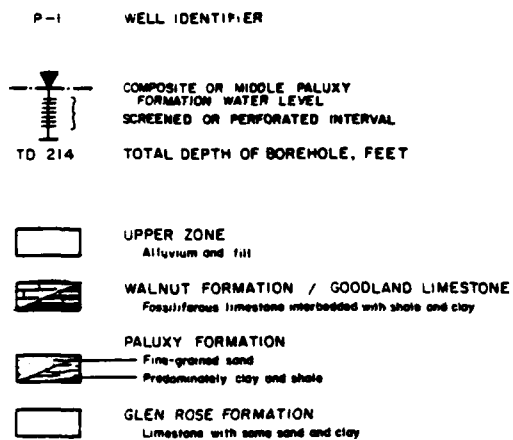
Figure 2-7. Continued

Figure 2-7. Generalized North-South Cross-Section through AF Plant 4, Texas (From Hargis & Associates, 1985).

GEOLOGY FROM LITHOLOGIC LOGS OF MIDDLE PALUXY WELLS
(UPPER PALUXY WELLS PROJECTED) ELEVATION OF LAND
SURFACE IS APPROXIMATE WATER LEVEL ELEVATIONS FROM
MARCH, 1985 DATA

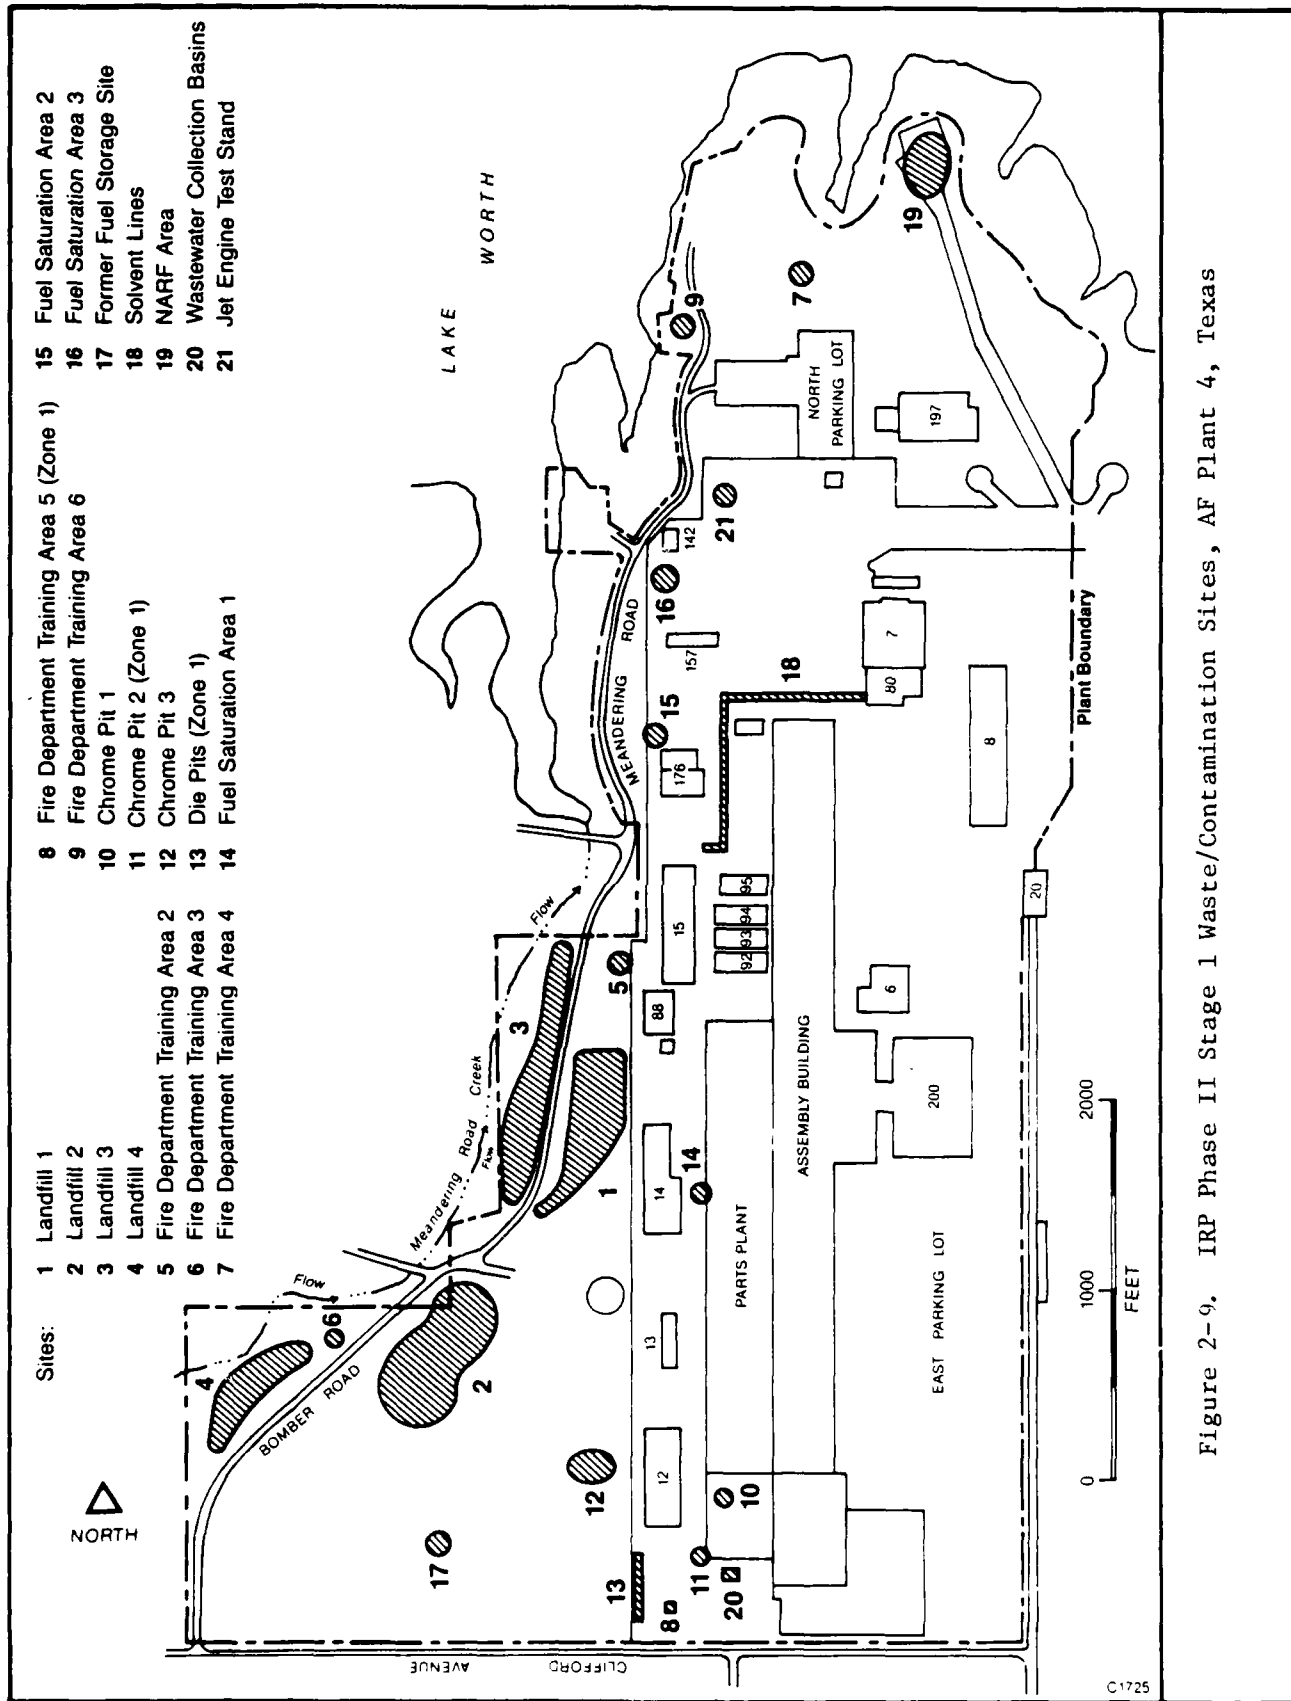
Figure 2-9. IRP Phase II Stage 1 Waste/Contamination Sites, AF Plant 4, Texas

Site 1, Landfill 1
Site 3, Landfill 3
Site 12, Chrome Pit 3
Site 17, Former Fuel Storage Site
Site 2, Landfill 2
Site 4, Landfill 4
Zone 1 (Site 13, Die Pits; Site 11, Chrome Pit 2; Site 8, FDTA 5)
Site 15, Fuel Saturation Area (FSA) 2
Site 20, Wastewater Collection Basins
Site 16, Fire Saturation Area 3
Site 9, Fire Department Training Area (FDTA) 6
Site 6, Fire Department Training Area 3
Site 7, Fire Department Training Area 4
Site 18, Solvent Lines
Site 10, Chrome Pit 1
Site 5, Fire Department Training Area 2
Site 14, Fire Saturation Area 1
Site 19, Nuclear Aerospace Research Facility (NARF) Area
Jet Engine Test Stand, Building 21

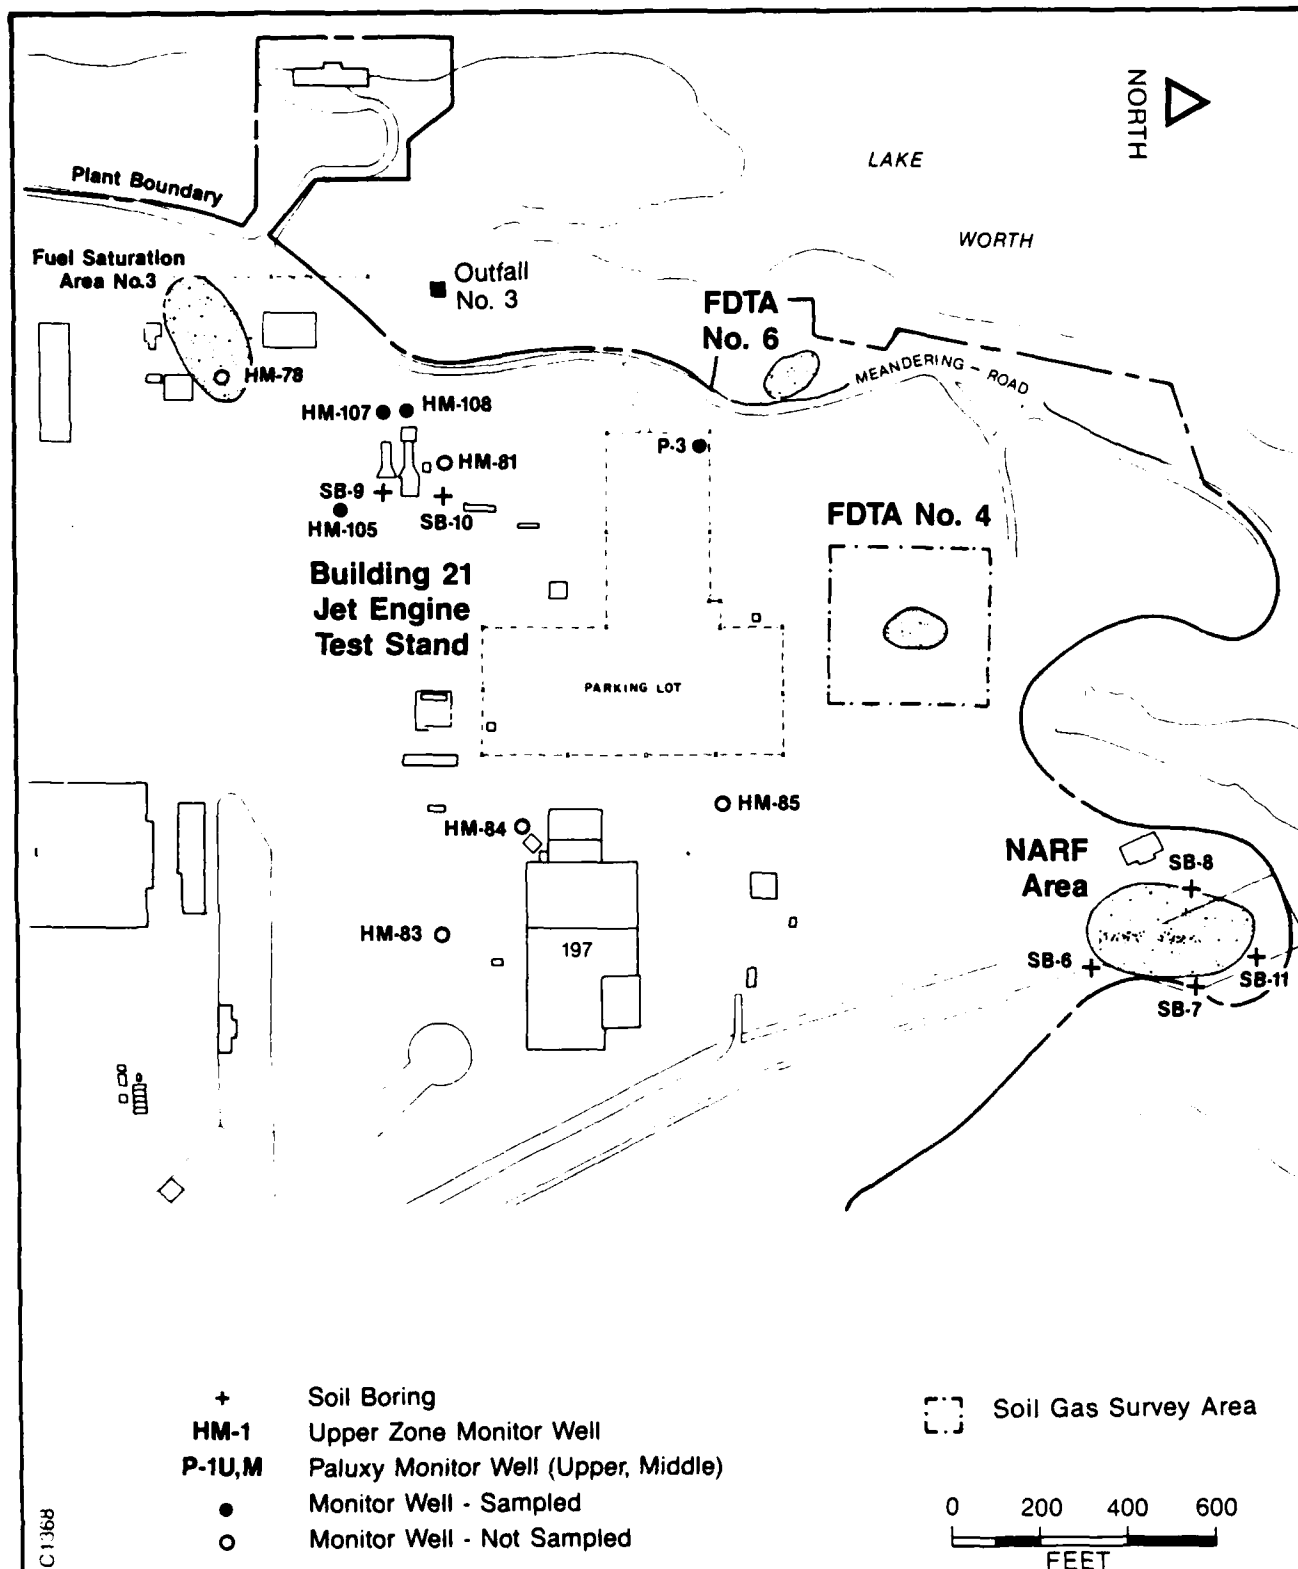
Figure 2-15. Location Map for Building 21, Jet Engine Test Stand; Sites 7 and 9, Fire Department Training Areas 4 and 6; and Site 19, NARF Area, AF Plant 4, Texas

employee parking area, at a location known as "Tater Hill" (Figure 2-15). Training exercises used the same amount of waste fuels and oils. Since the site is not readily visible on historical aerial photographs of AF Plant 4, its location and present condition have not been accurately determined.

The Nuclear Aerospace Research Facility (NARF) formerly located at the north end of AF Plant 4 (Figure 2-15), housed several experimental atomic reactors between 1953 and 1974. The facility was decommissioned and disposed of by contractor in 1974.

This site, a jet engine test building, (Figure 2-15) was not previously identified in Phase I. It is located north of a fuels test area, previously identified as Site 16 and a known area of fuel contamination. The sump downslope of Building 21, constructed in 1975, collects water used for cooling, noise suppression, and clean up in Building 21. This water is pumped into the industrial waste line. The area immediately south of Building 21 contains two underground tanks once used for fuel storage. These tanks, along with all others, are being investigated as potential sources of contamination by the operating contractor, General Dynamics. Outfall 3, downgradient of Building 21, is regularly sampled as part of IRP and NPDES monitoring activities.

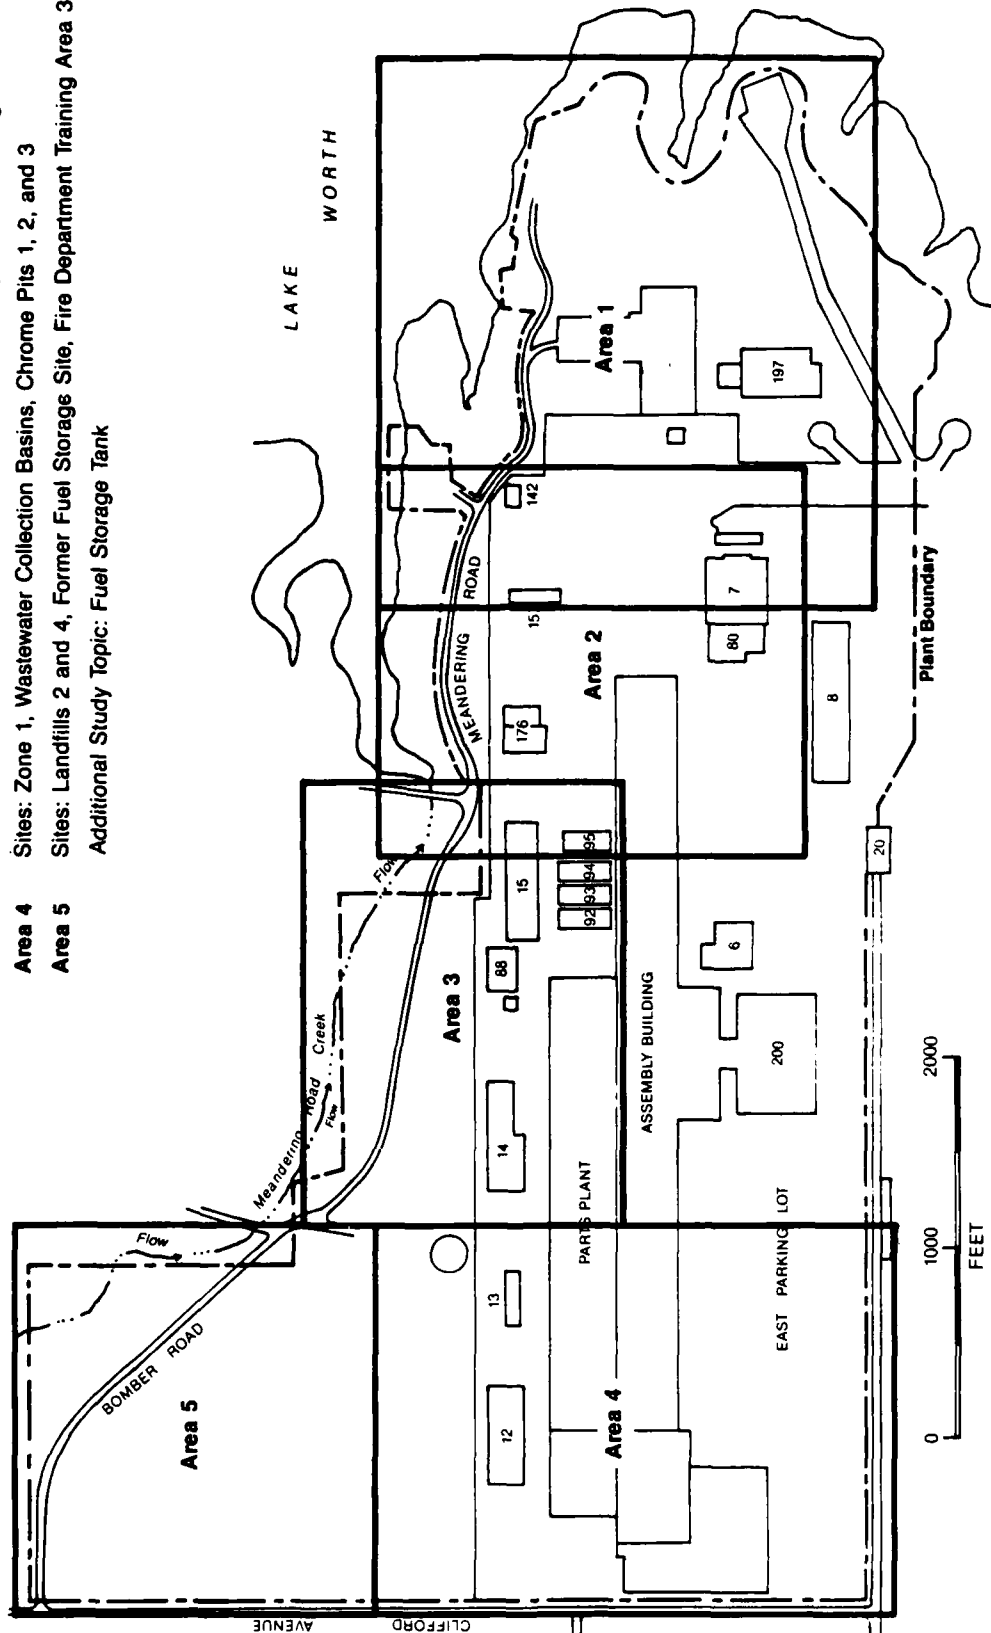
Figure 3-1. Index Map for Individual Area Maps, AF Plant 4, Texas

Field activities conducted at each site in the AF Plant 4 IRP Phase II Stage 1 investigation are described in the following subsections. Site activities are presented and discussed in the order in which they appear in the delivery order. Wells and sampling activities are discussed with their associated sites in the Statement of Work. Figure 3-1 is an index map showing

- Area 1** Sites: Jet Engine Test Stand, Fire Department Training Areas 4 and 6, NARF Area
- Area 2** Sites: Solvent Lines, Fuel Saturation Areas 2 and 3
- Area 3** Sites: Landfills 1 and 3, Fuel Saturation Area 1, Fire Department Training Area 2
- Area 4** Sites: Zone 1, Wastewater Collection Basins, Chrome Pits 1, 2, and 3
- Area 5** Sites: Landfills 2 and 4, Former Fuel Storage Site, Fire Department Training Area 3
- Additional Study Topic: Fuel Storage Tank

the areas covered by the site-specific maps presented in the following sections. Site activities are summarized in Table 3-4.

the results of Phase II Stage 1 monitoring. Separate maps are presented for each area of the plant identified in Figure 3-1 and for the East Parking Lot Area.

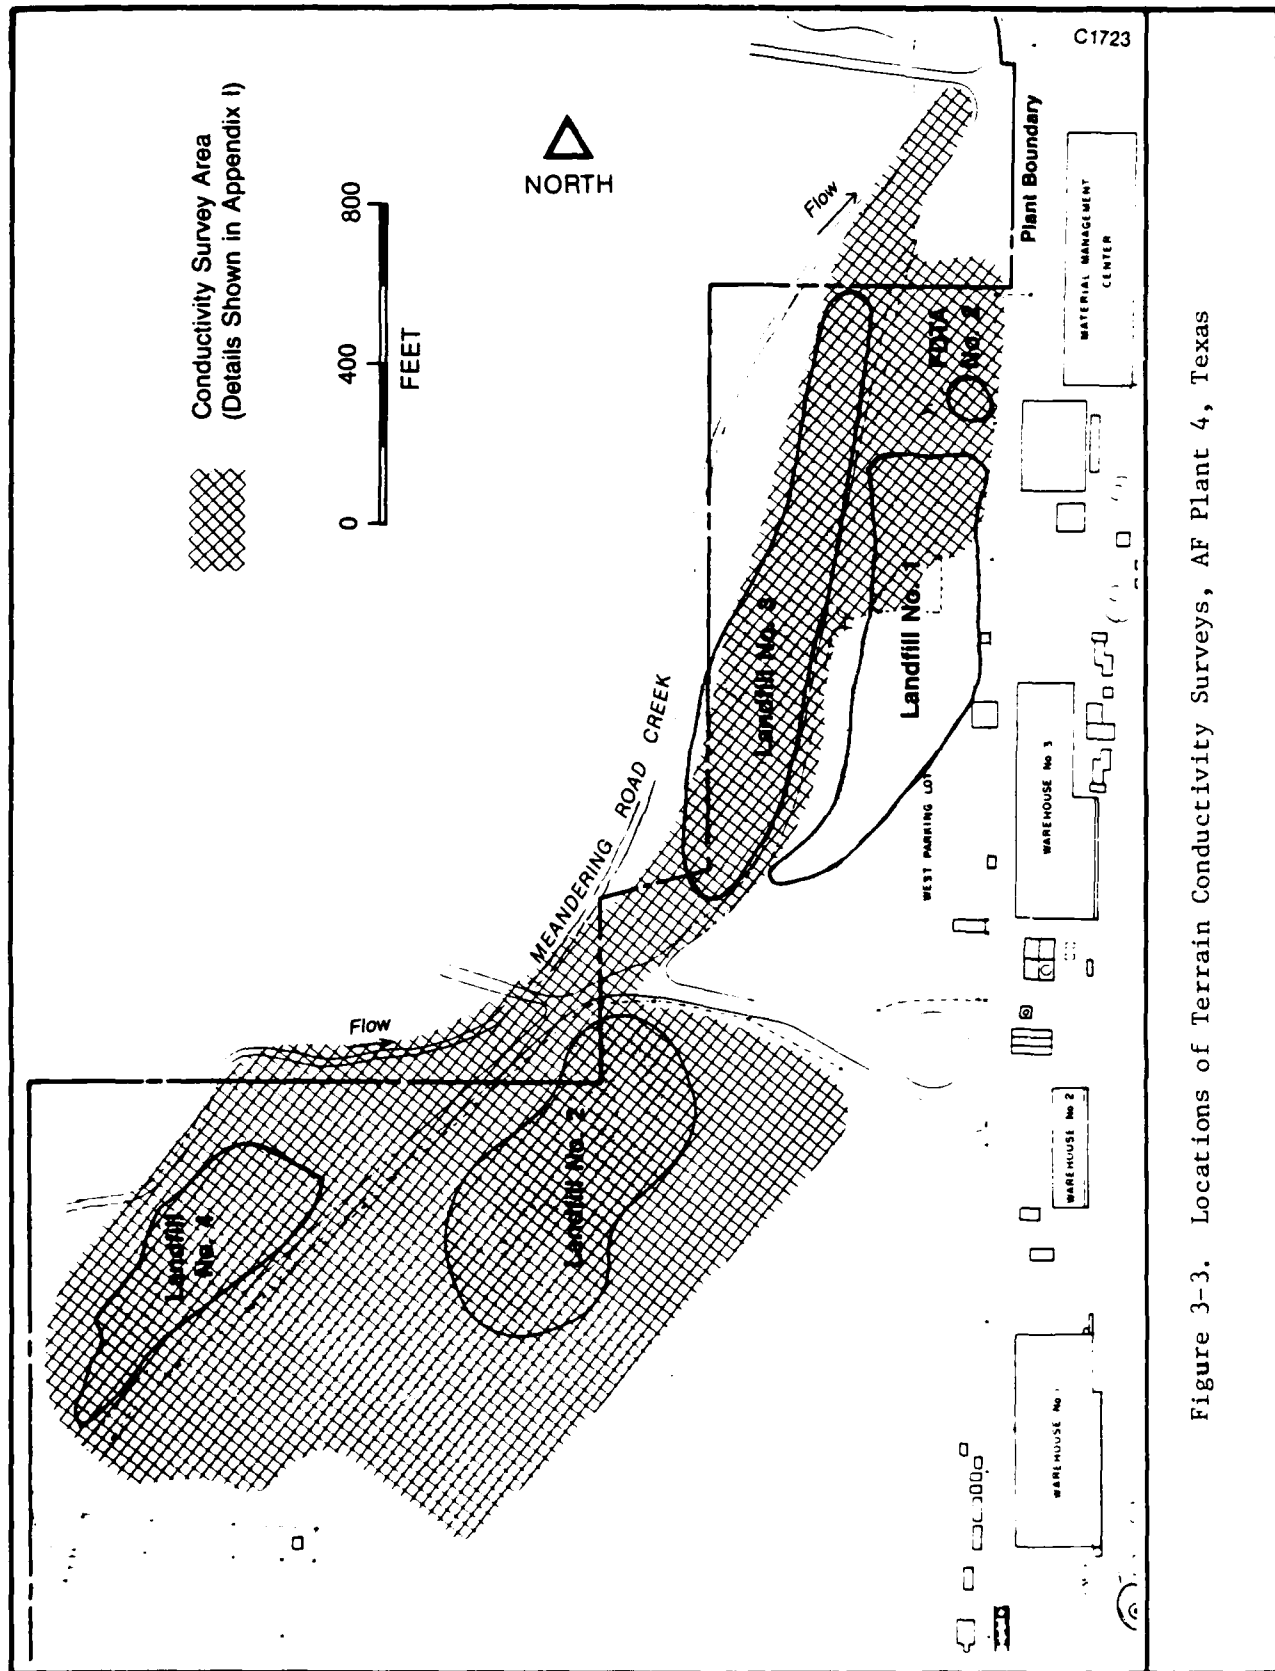
Figure 3-3. Locations of Terrain Conductivity Surveys, AF Plant 4, Texas

Terrain Conductivity Survey: The purpose of the terrain conductivity survey conducted in November 1985 was to determine the presence and configuration of waste disposal areas. This was accomplished using electromagnetic profiling to measure electrical conductivities of the subsurface material. To perform the survey at Landfill 3, a grid was established, as described in Section 3.1.1. Figure 3-3 illustrates the area of the survey at Landfill 3, as well as the other survey locations at AF Plant 4. The area of the terrain conductivity survey grid is approximately 2100 by 250 feet. Electromagnetic profile readings were taken every 30 feet.

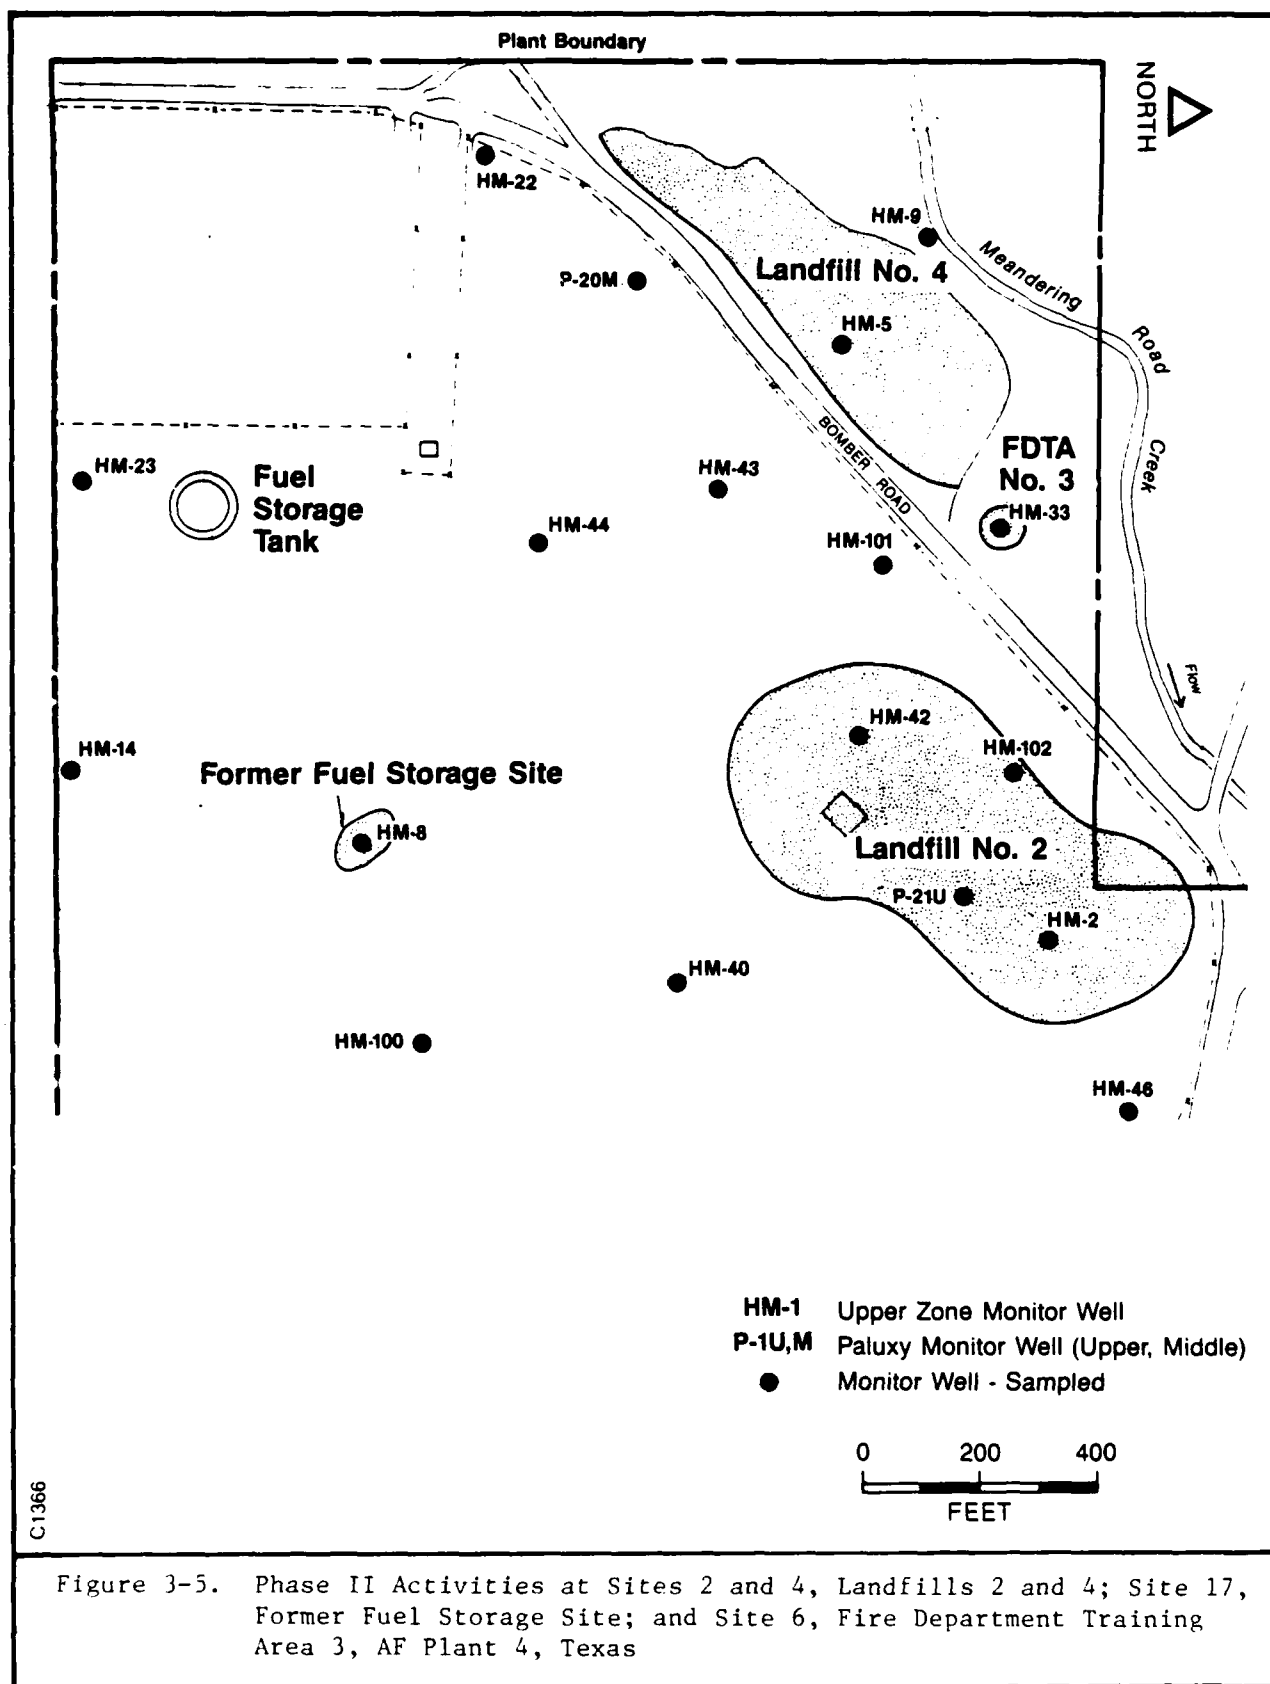
Investigation activities at Landfill 2 included: performance of geophysical surveying, installation of a monitor well (P-21U) completed in the upper member of the Paluxy Formation, and collection of groundwater samples from seven existing monitor wells and the newly installed Paluxy monitor well. Figure 3-5 shows the location of Landfill 2.

Terrain Conductivity Survey: The purpose of the terrain conductivity survey was to determine the presence and configuration of waste disposal areas. This was accomplished by using electromagnetic profiling to measure electrical conductivities of the subsurface material. To perform the survey at Landfill 2 a grid was established, as described in Section 3.1.1. Figure 3-3 illustrates the area of the survey at Landfill 2, as well as the other EMP survey locations at AF Plant 4. The area of the EMP survey grid is approximately 1800 by 800 feet. Electromagnetic profile readings were taken every 30 feet. The survey was performed in November, 1985.

Monitor Well Installation: One new monitor well (P-21U) was installed in the Landfill 2 area. The well was completed in the upper member of the Paluxy Formation. Soil samples were taken as described in Section 3.1.3, along with samples of drilling fluids. The location of P-21U was selected to complement the existing Paluxy well network and determine the quality of groundwater downgradient of Landfill 2 and of other waste disposal areas.

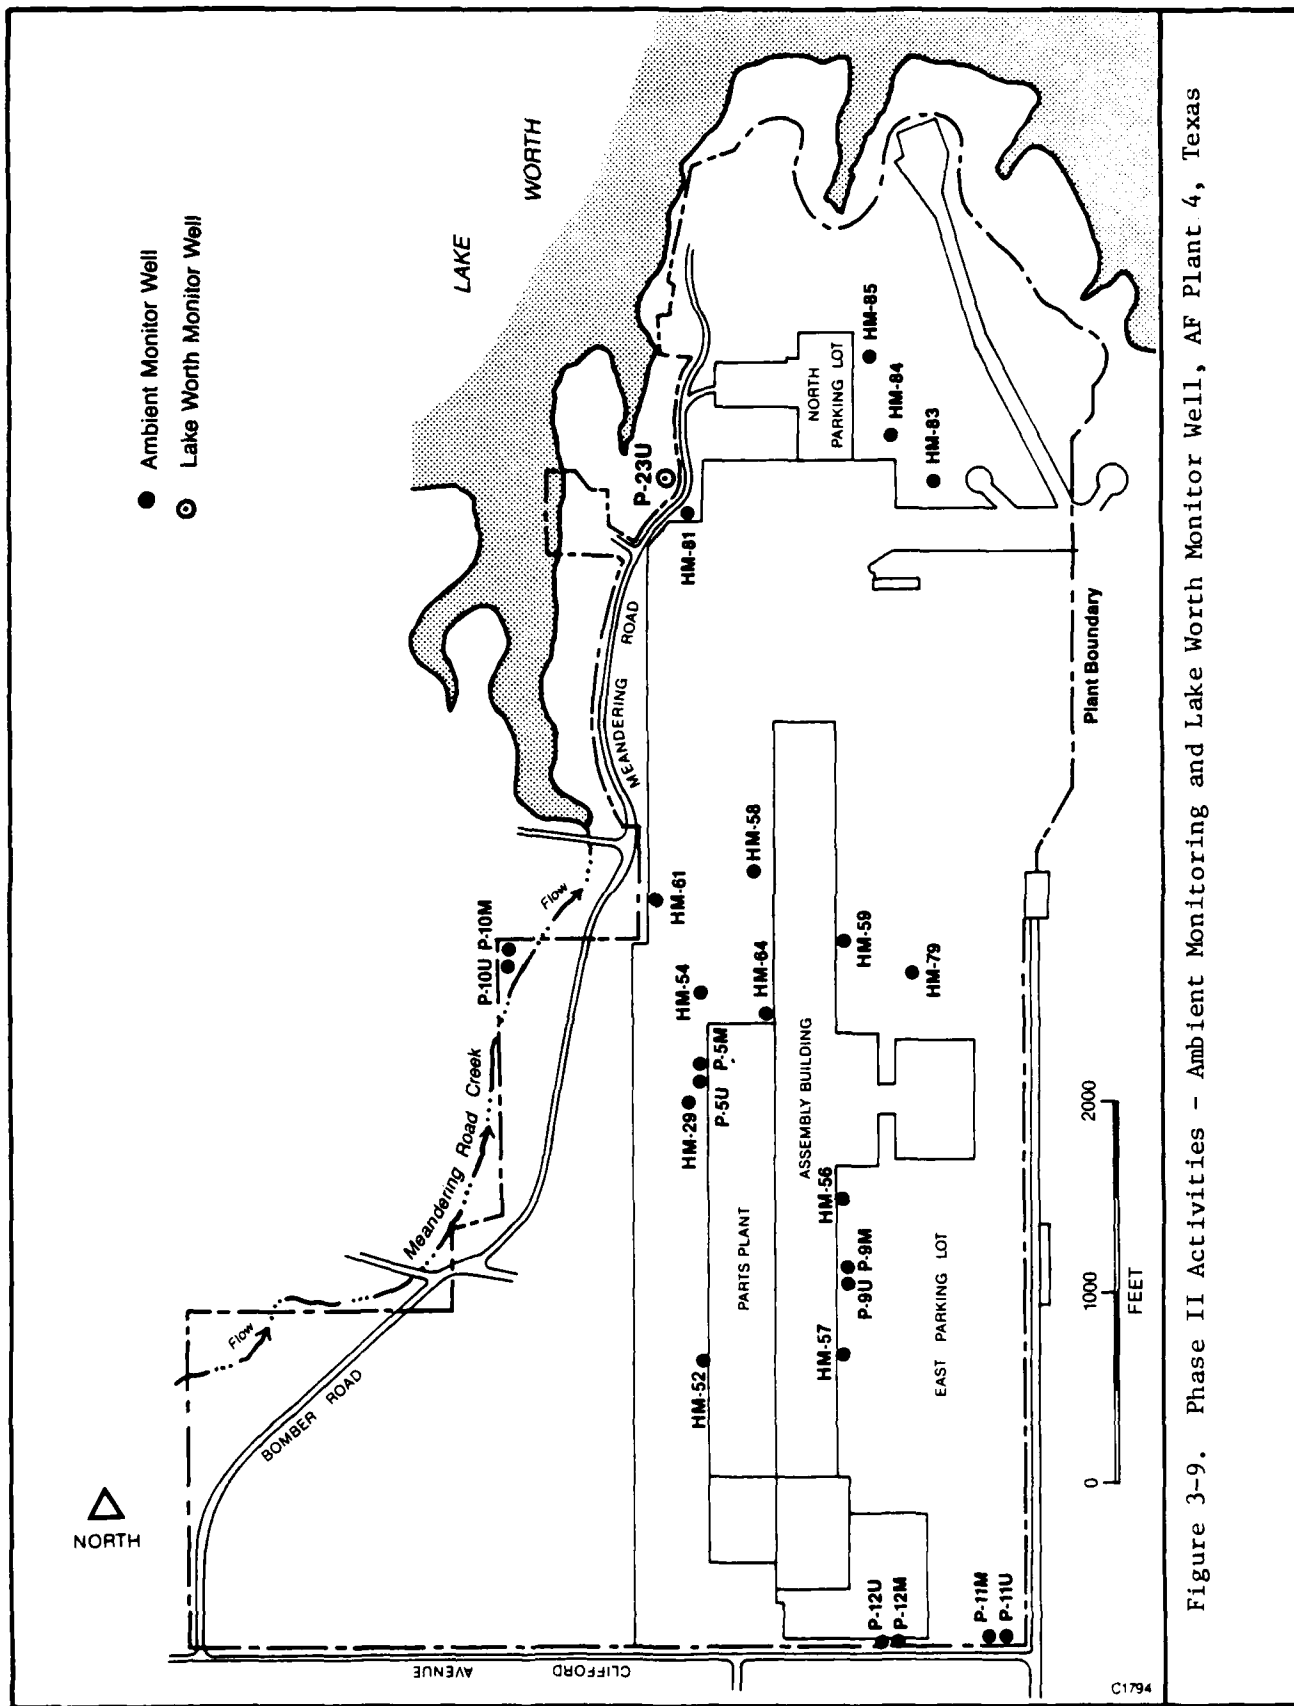
Figure 3-9. Phase II Activities - Ambient Monitoring and Lake Worth Monitor Well, AF Plant 4, Texas

Lake Worth Monitor Well	1. Install 1 Paluxy well near Lake Worth.	1. Evaluate groundwater quality of Paluxy aquifer near recharge source, Lake Worth.	Figure 3-9.

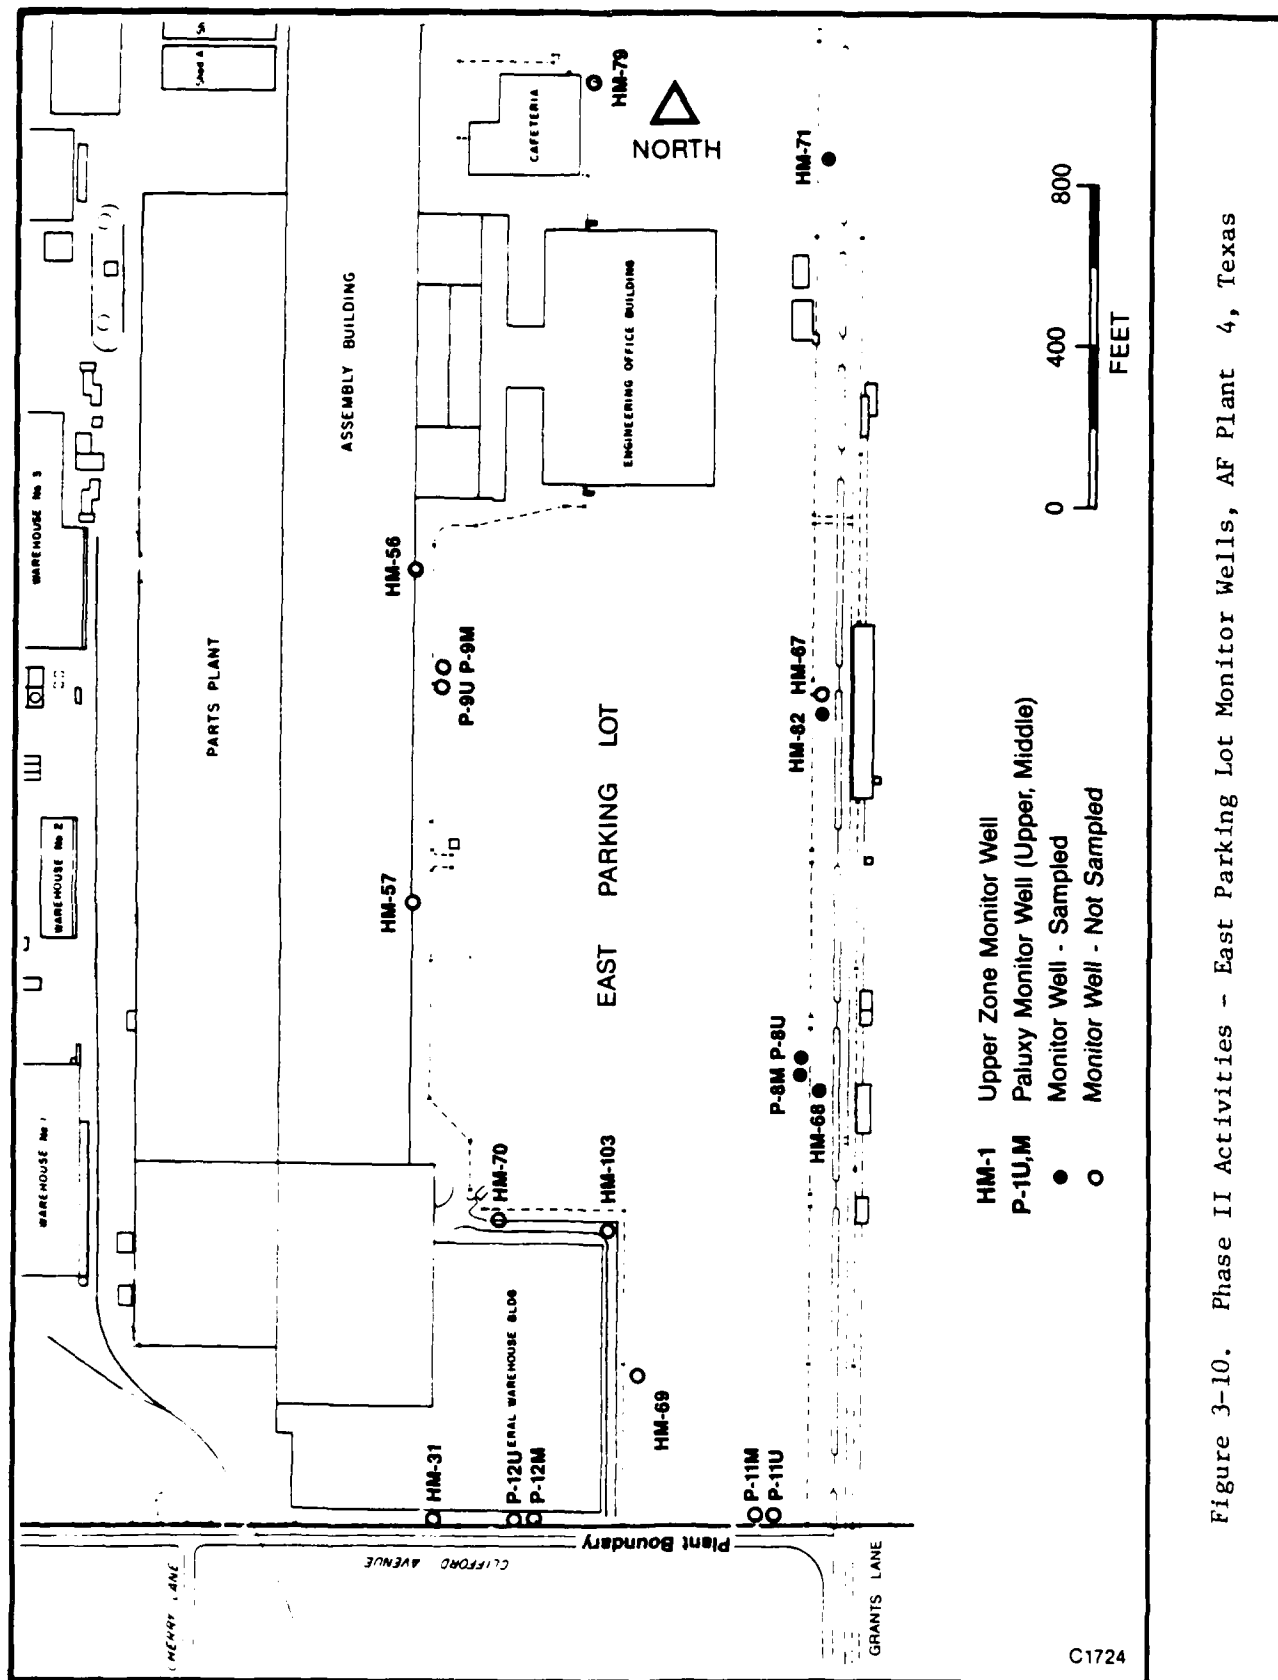
Figure 3-10. Phase II Activities - East Parking Lot Monitor Wells, AF Plant 4, Texas

Investigation activities for the East Parking Lot involved the collection of groundwater samples from three existing upper zone monitor wells and two Paluxy monitor wells (Figure 3-10). The purpose of this activity was to gain continuing information on the quality of groundwater in the upper zone and Paluxy aquifer in areas not directly associated with waste disposal sites.

Radian personnel performed groundwater sampling from 3 to 28 February 1986. One sample was collected from each of HM-68, 71, and 82; and P-8U and 8M. Details of the sampling procedures are given in Section 3.1.5.3. Groundwater samples were analyzed for VOC, BNA, oil and grease, hydrocarbon fuel, and heavy metals (chromium was also specified for analysis in the delivery order, but this parameter was already included in the parameter list of heavy metals). Results of the analyses are presented in Section 4.3.21.
